CR-184003

Final Report for the M-52 Spray Booth Qualification Test

July 1990

Thiokol CORPORATION
SPACE OPERATIONS

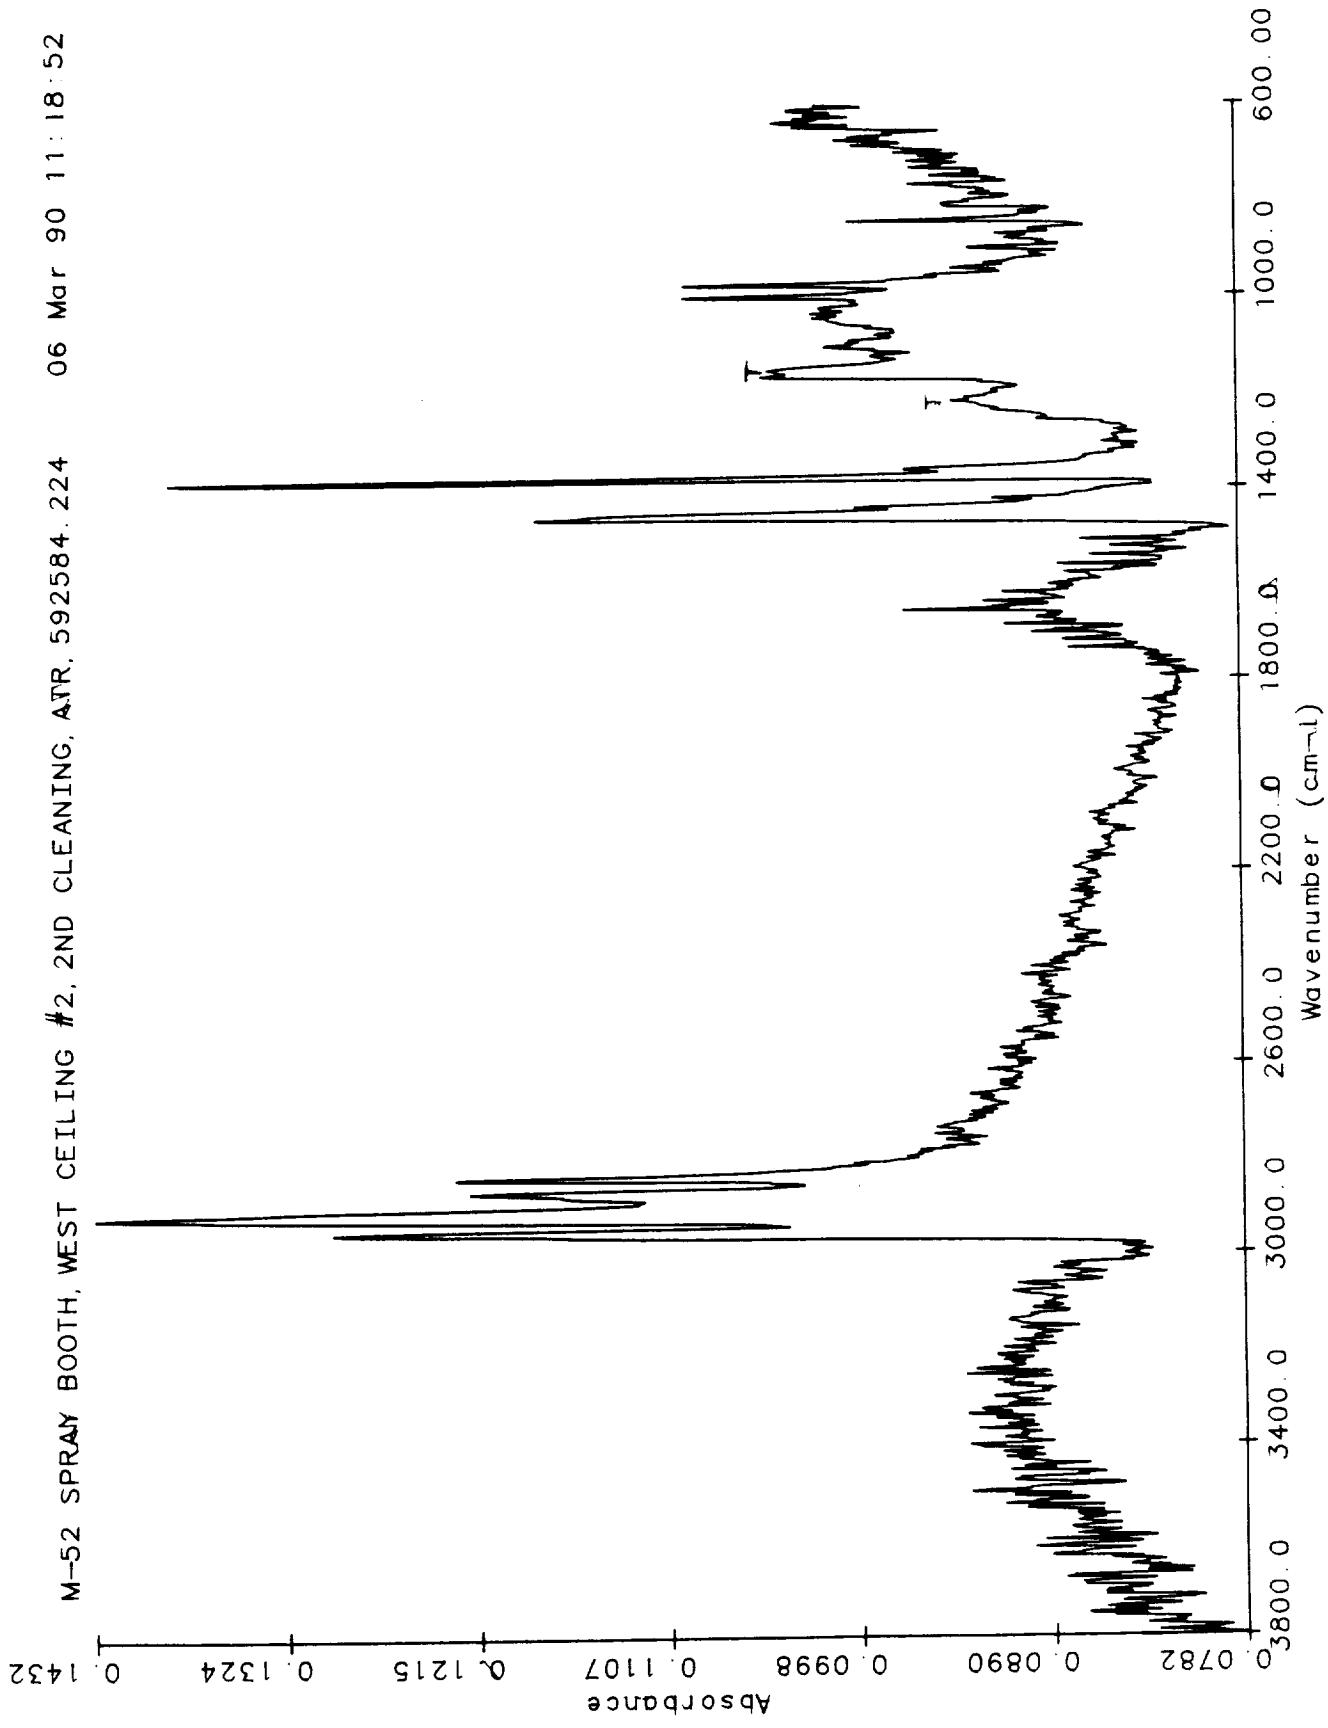
M-52 SPRAY BOOTH, WEST CEILING #2, 2ND CLEANING, ATR, 592584.224 06 Mar 90 11:18:52

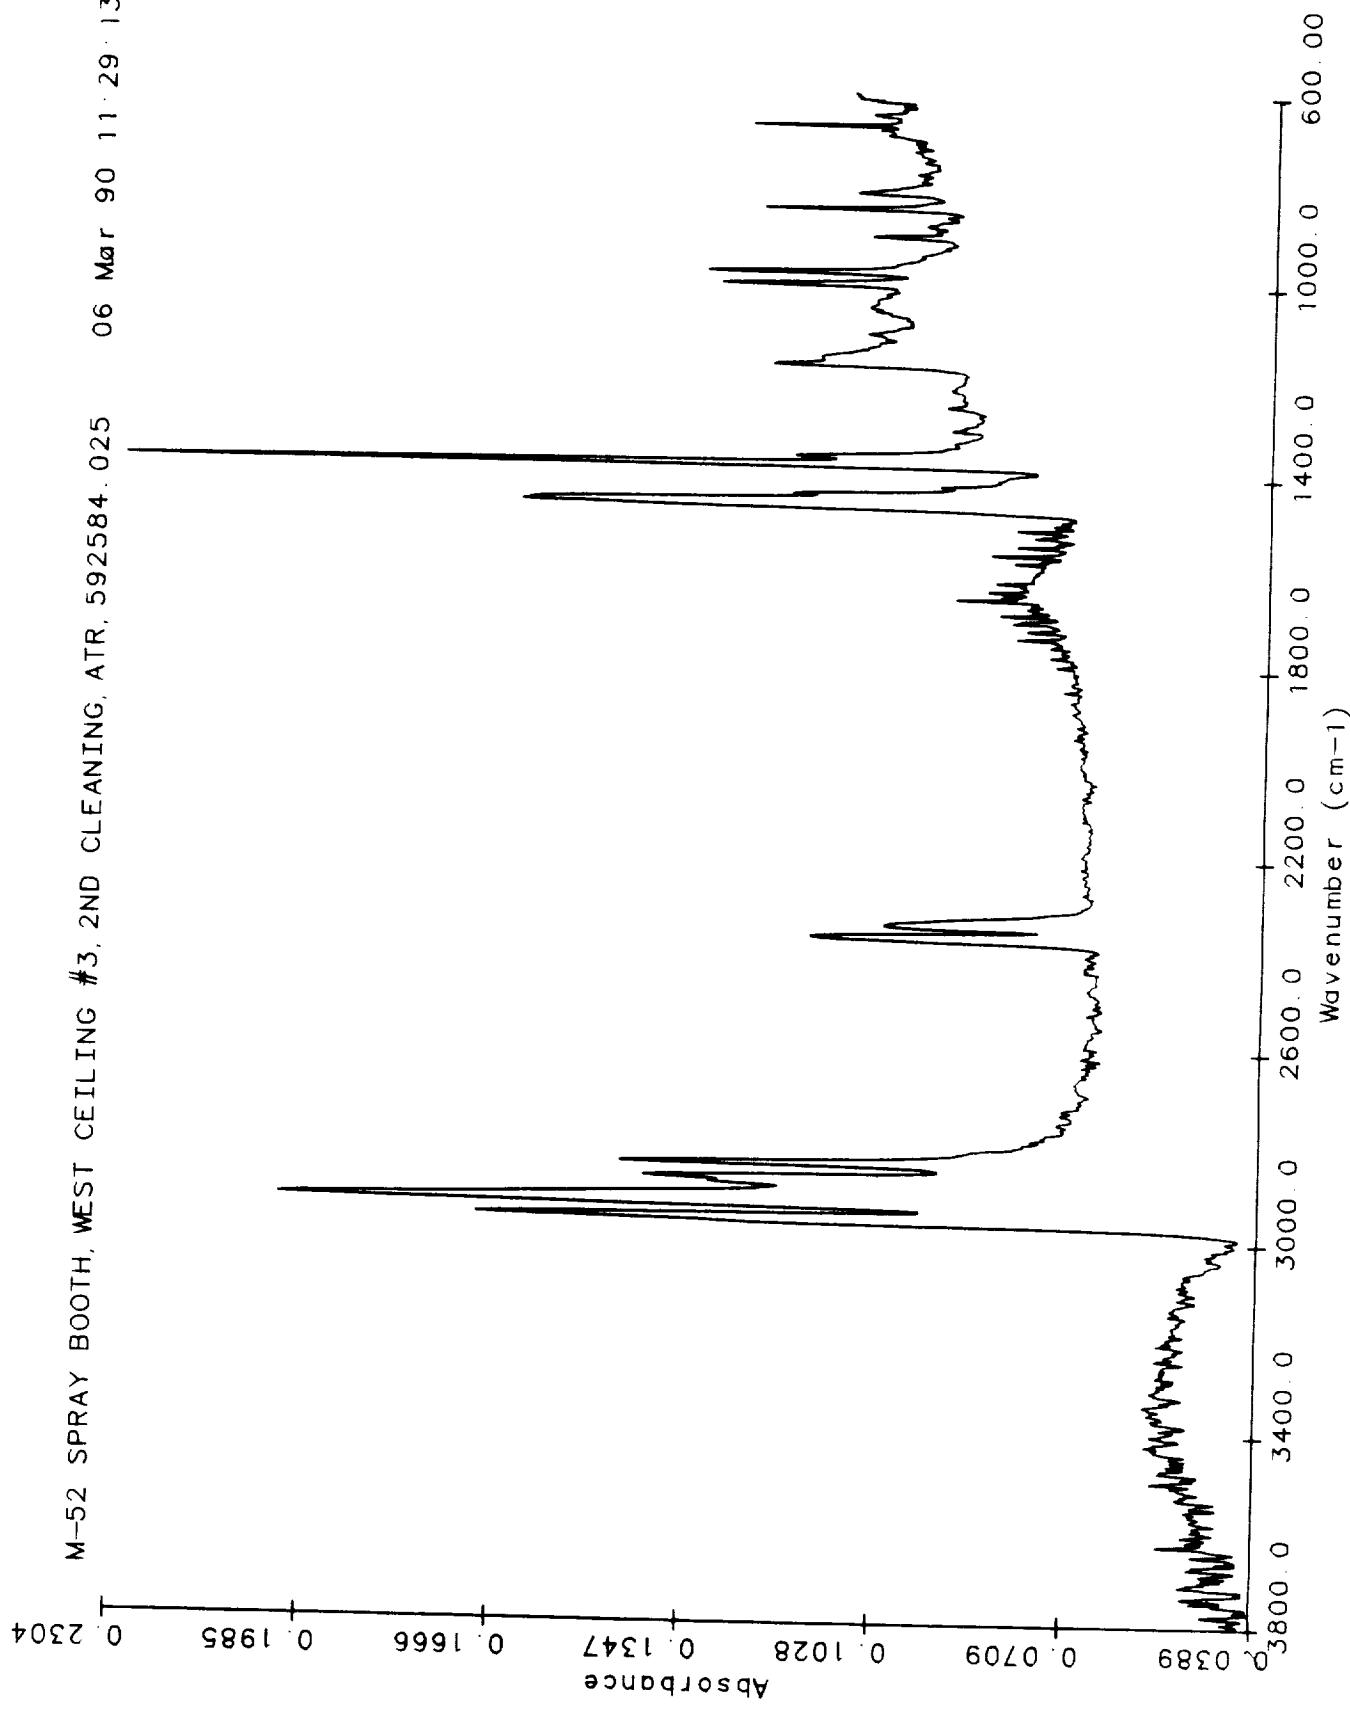
M-52 SPRAY BOOTH, WEST CEILING #3, 2ND CLEANING, ATR, 592584.025 06 Mar 90 11:29:13

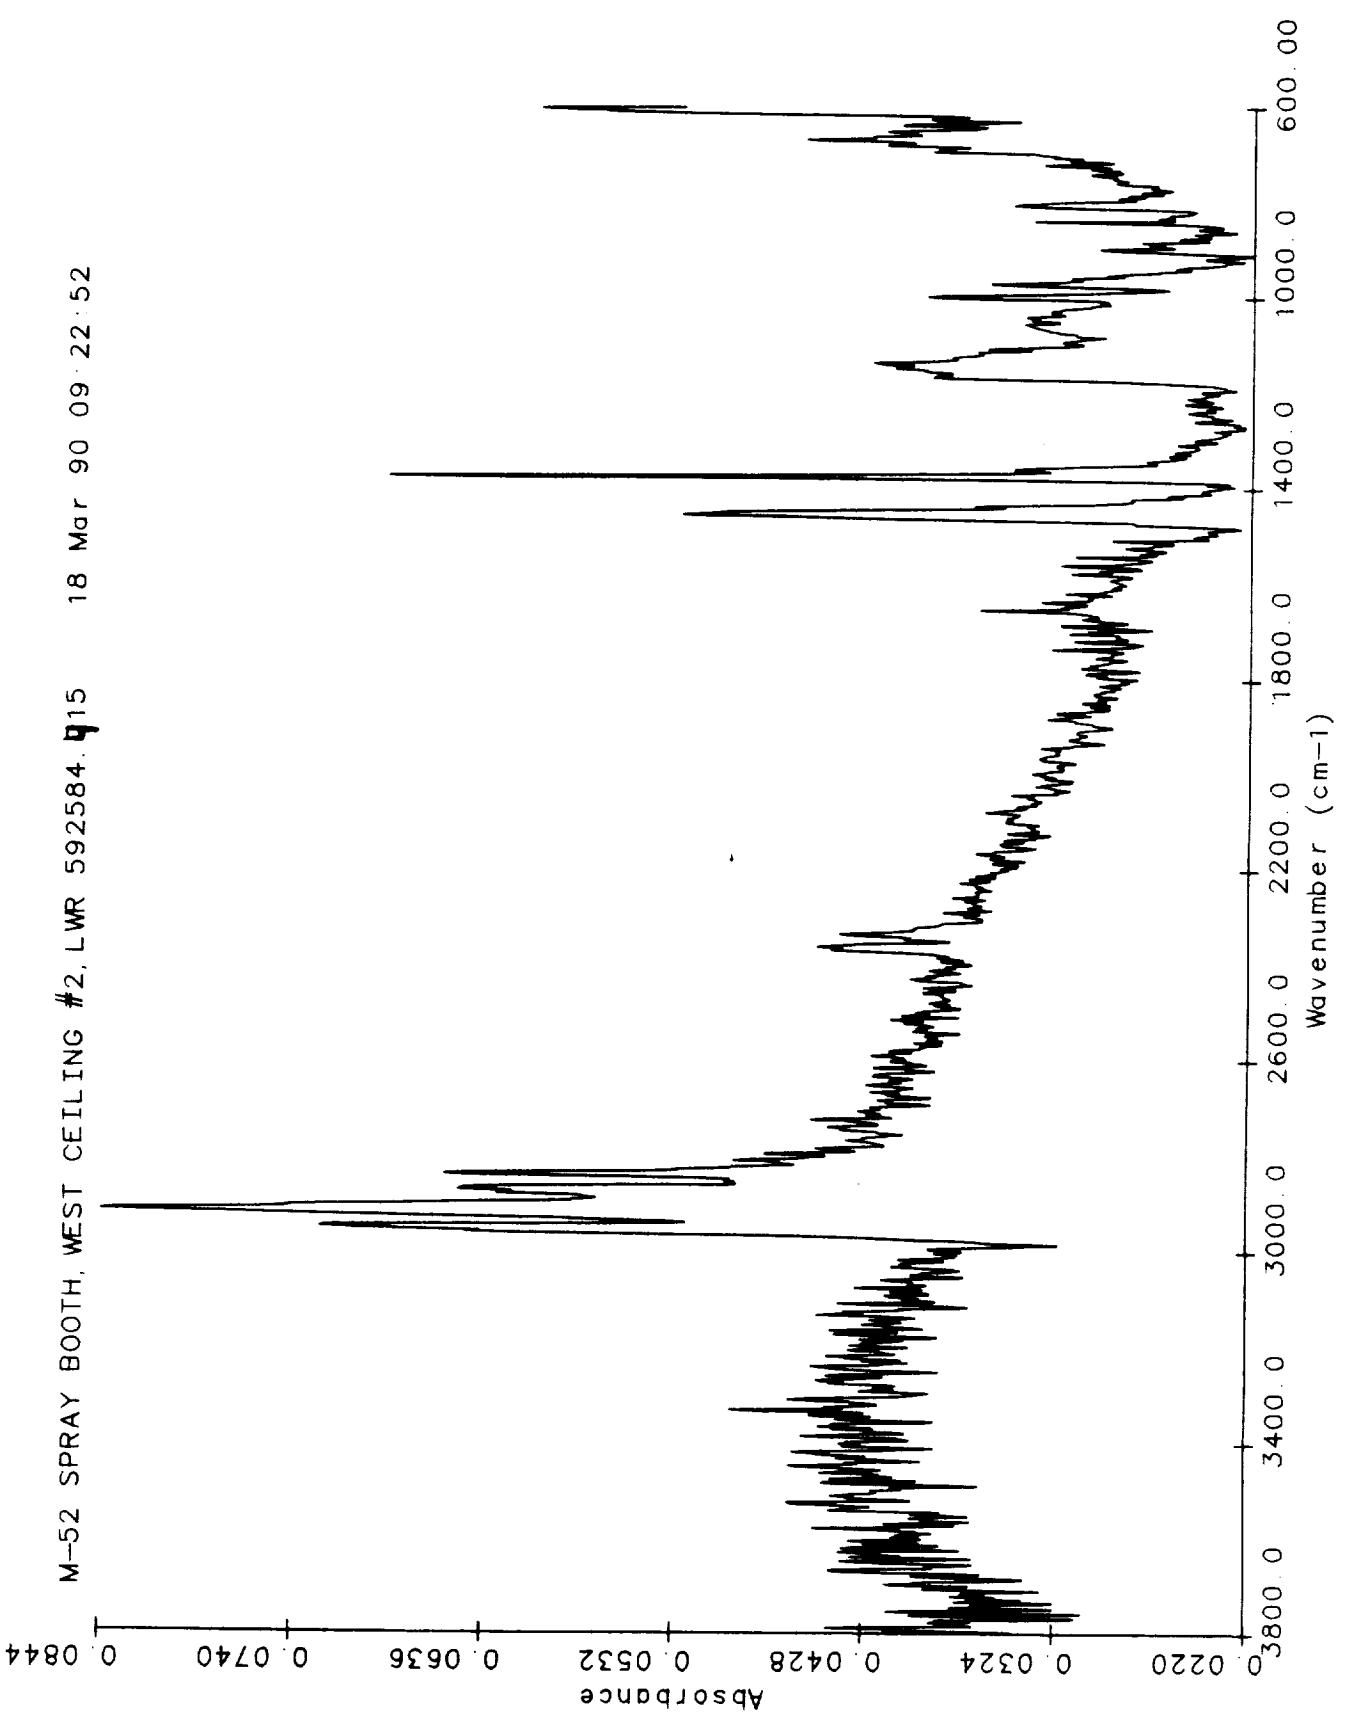
M-52 SPRAY BOOTH, WEST CEILING #2, LWR 592584. 115 18 Mar 90 09:22:52

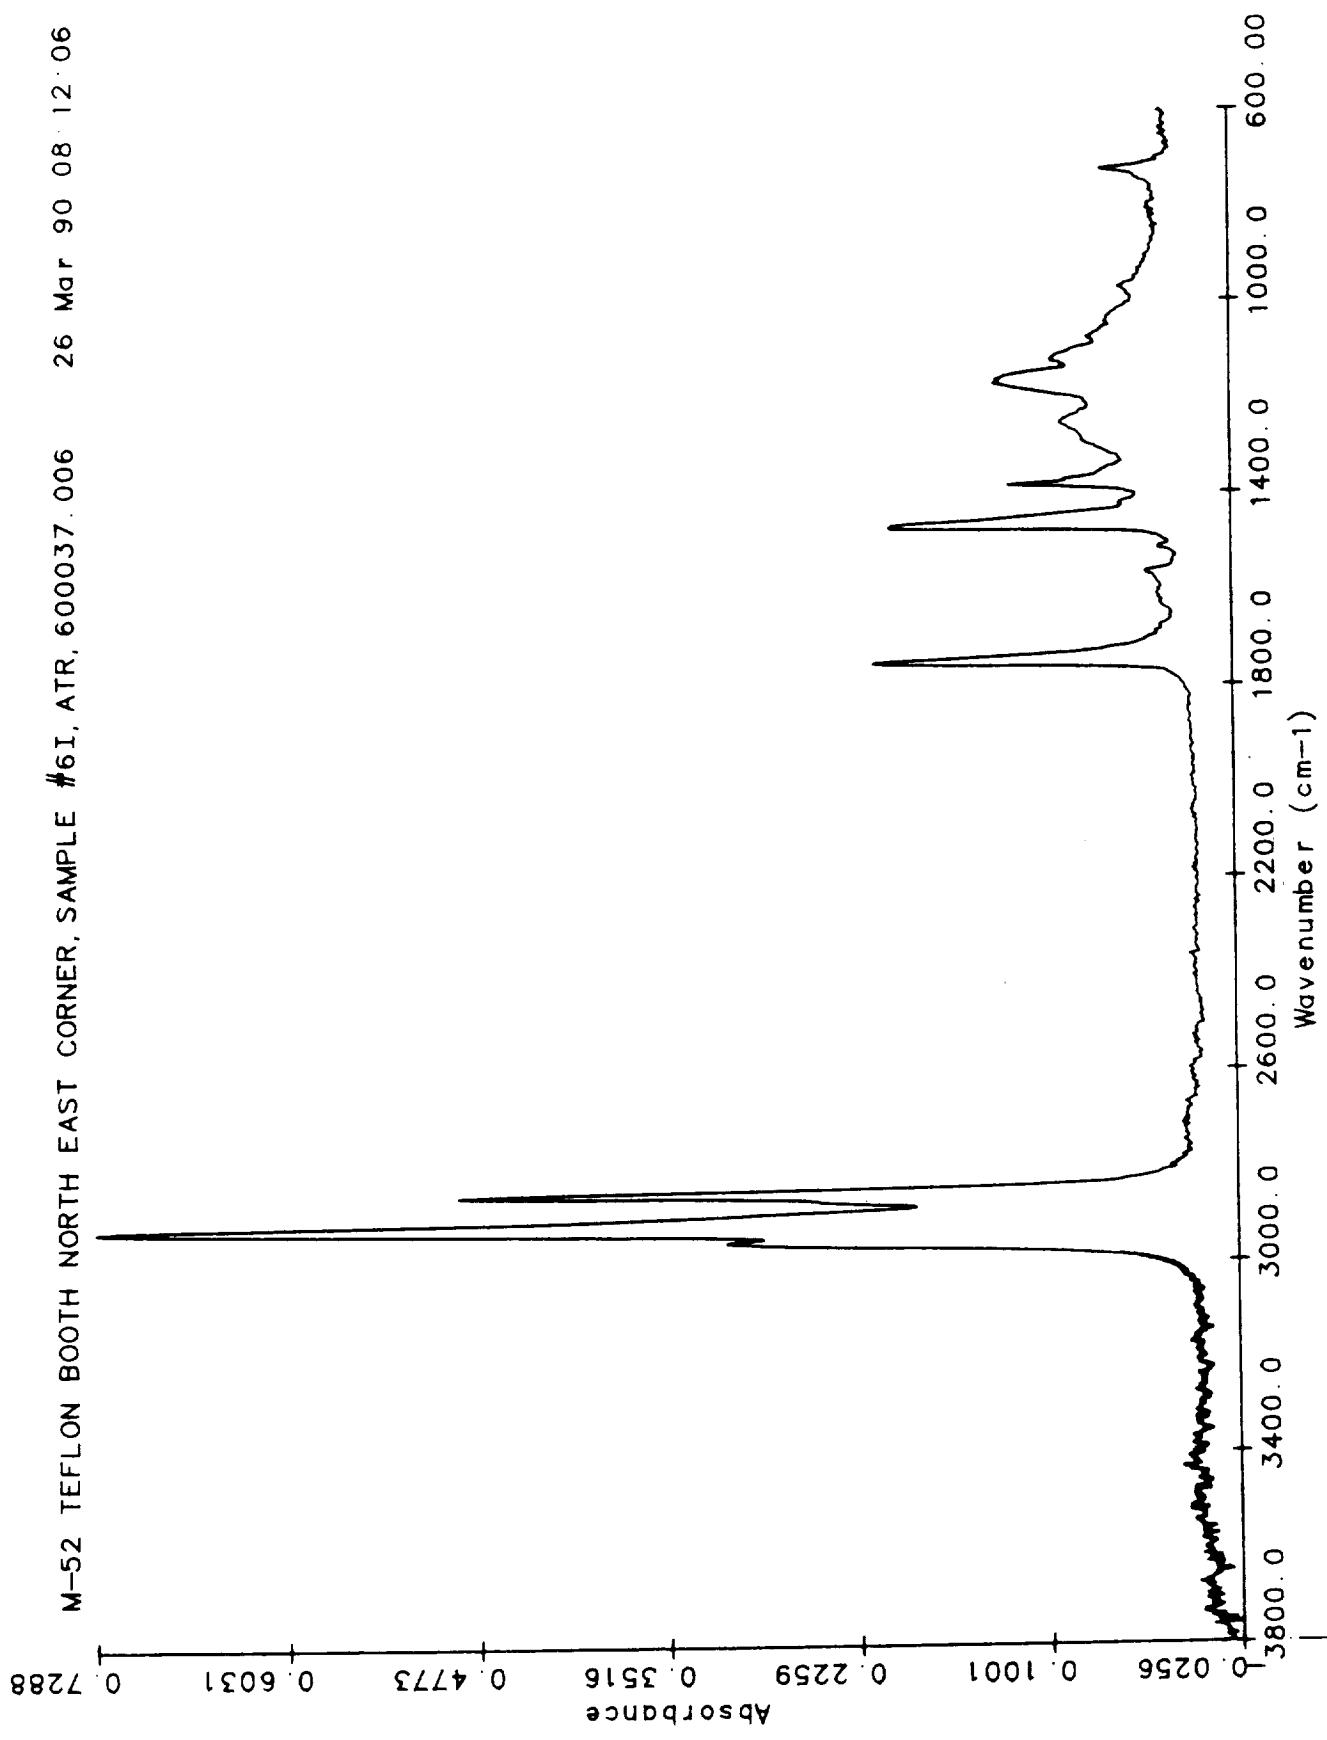
M-52 TEFLON BOOTH NORTH EAST CORNER, SAMPLE #6I, ATR, 600037. 006
26 Mar 90 08:12:06

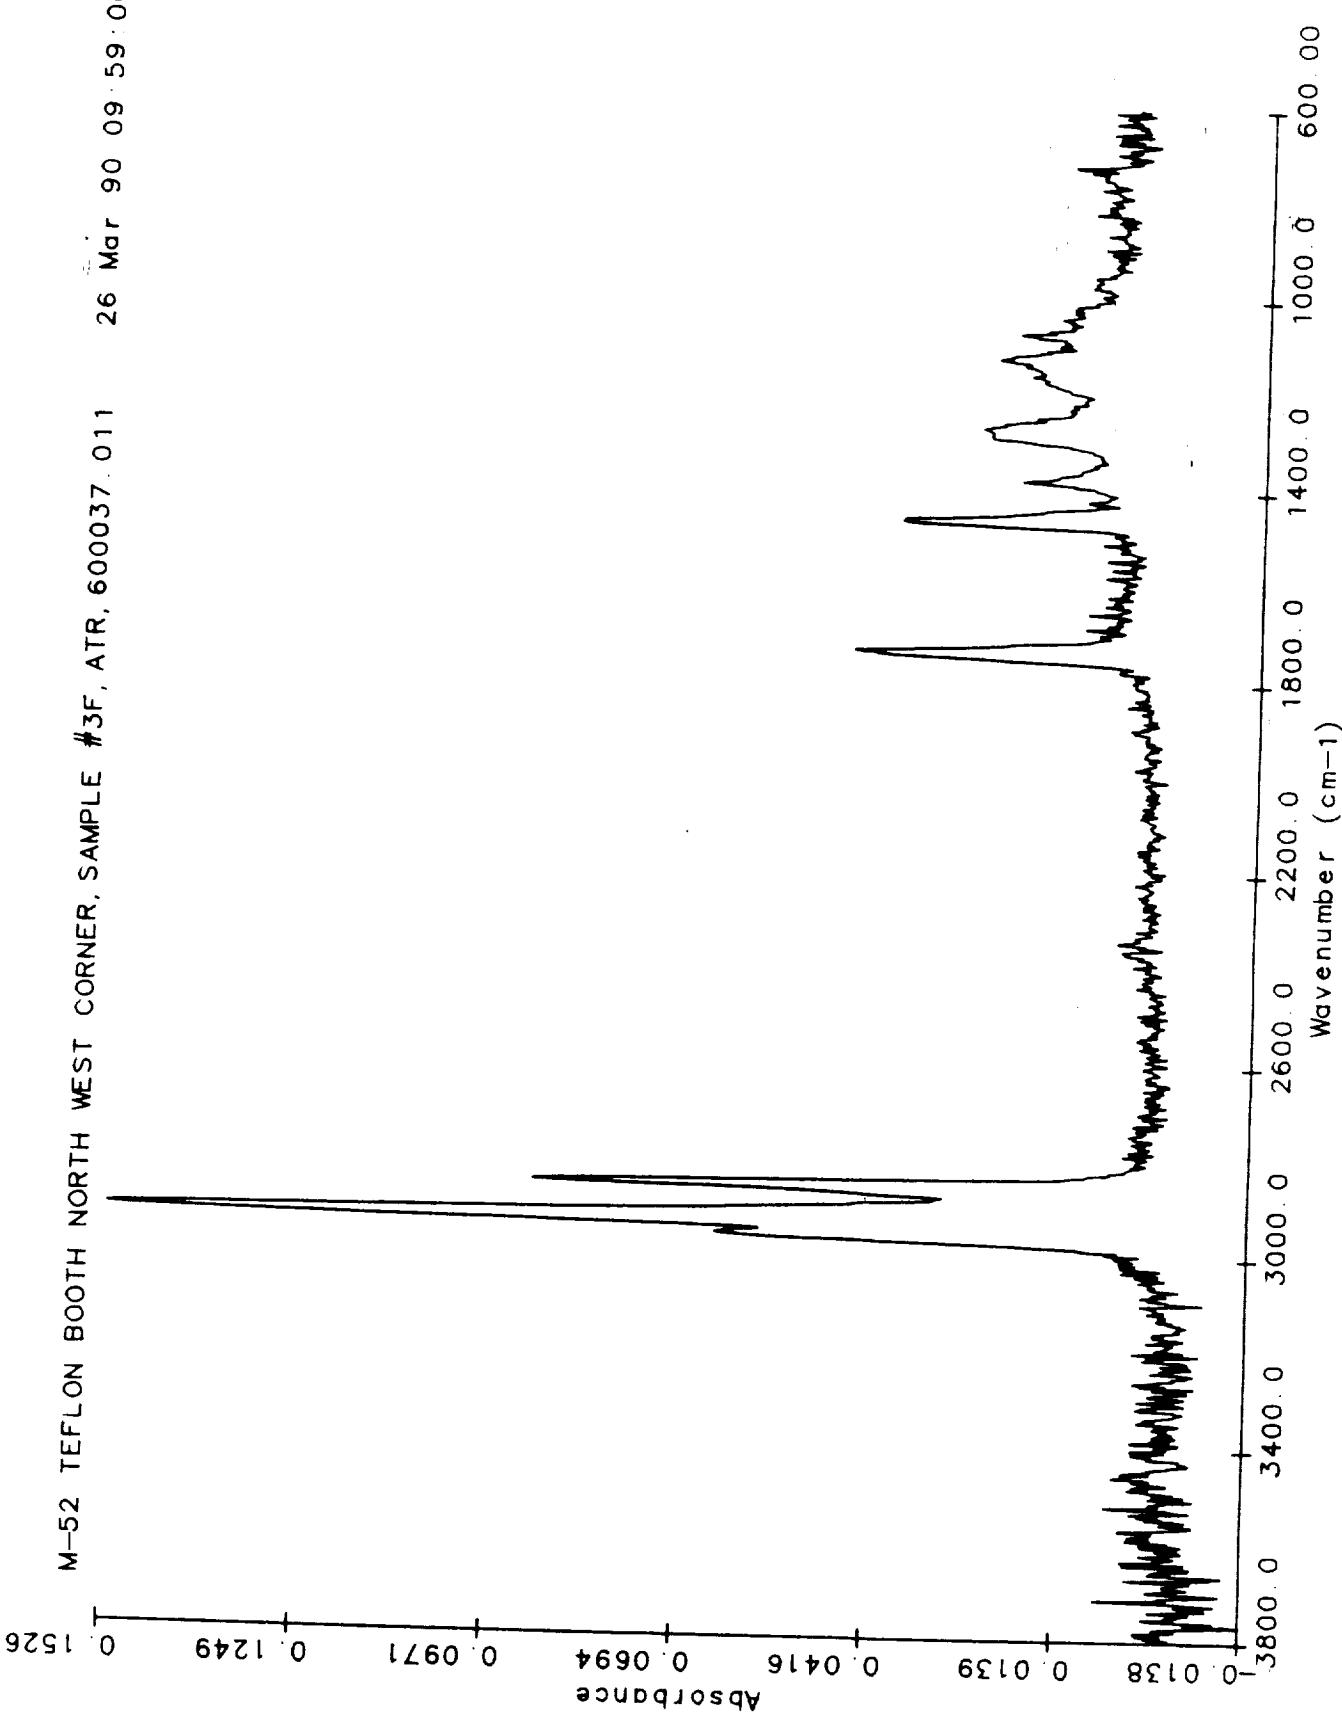
M-52 TEFLON BOOTH NORTH WEST CORNER, SAMPLE #3F, ATR, 600037.011

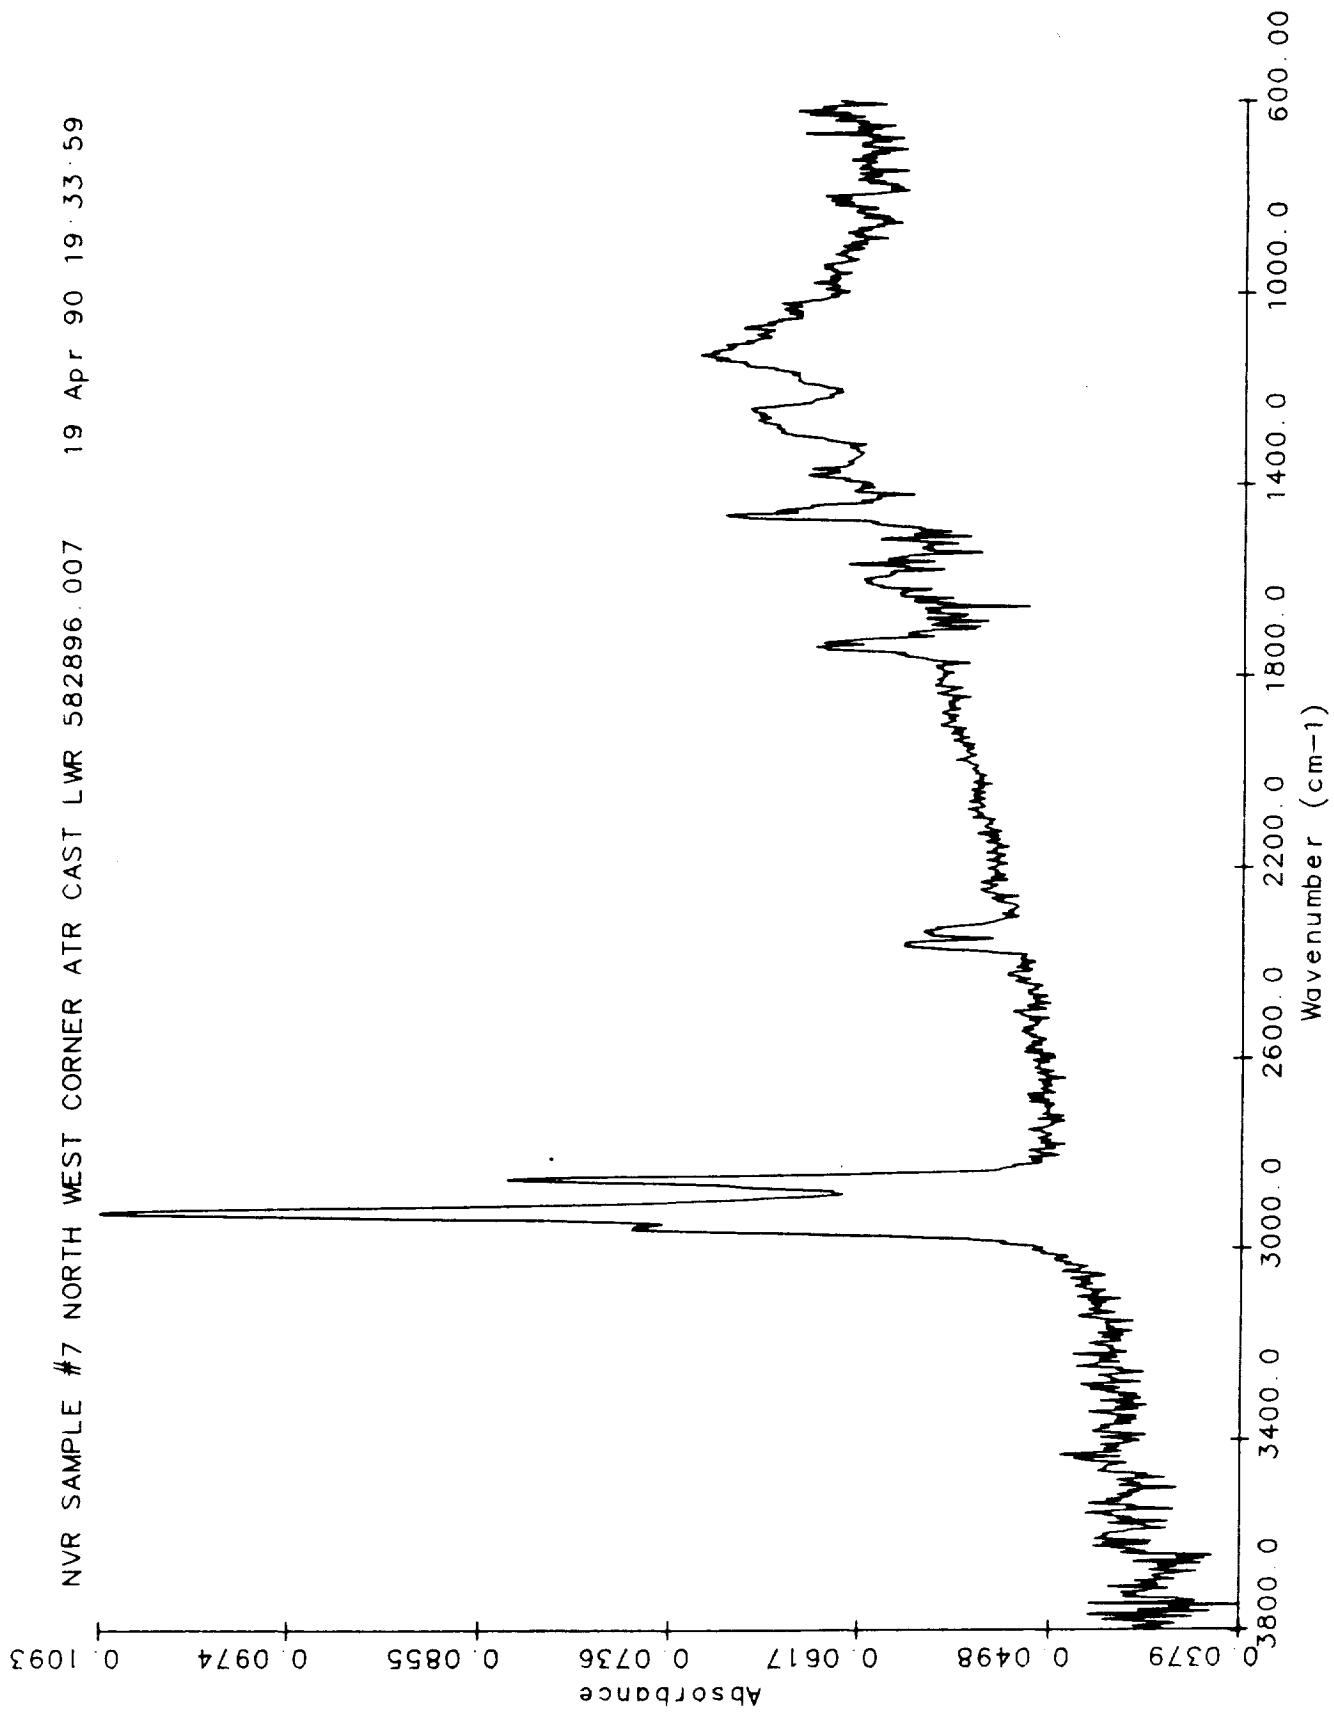
NVR SAMPLE #7 NORTH WEST CORNER ATR CAST LWR 582896.007 19 Apr 90 19:33:59
